## AN APPROACH FOR PRESERVING OTTOMAN CULTURAL HERITAGE UNDER THREAT IN YEMEN: A CASE STUDY " THE OLD CITY OF SANA'A "

This paper examines cultural heritage under threat, and this issue is specifically studied in the context of Ottoman heritage in the city of Sana'a. The study included important historical buildings built in Ottoman era, which consisted of military, religious, service, residential, and educational buildings.

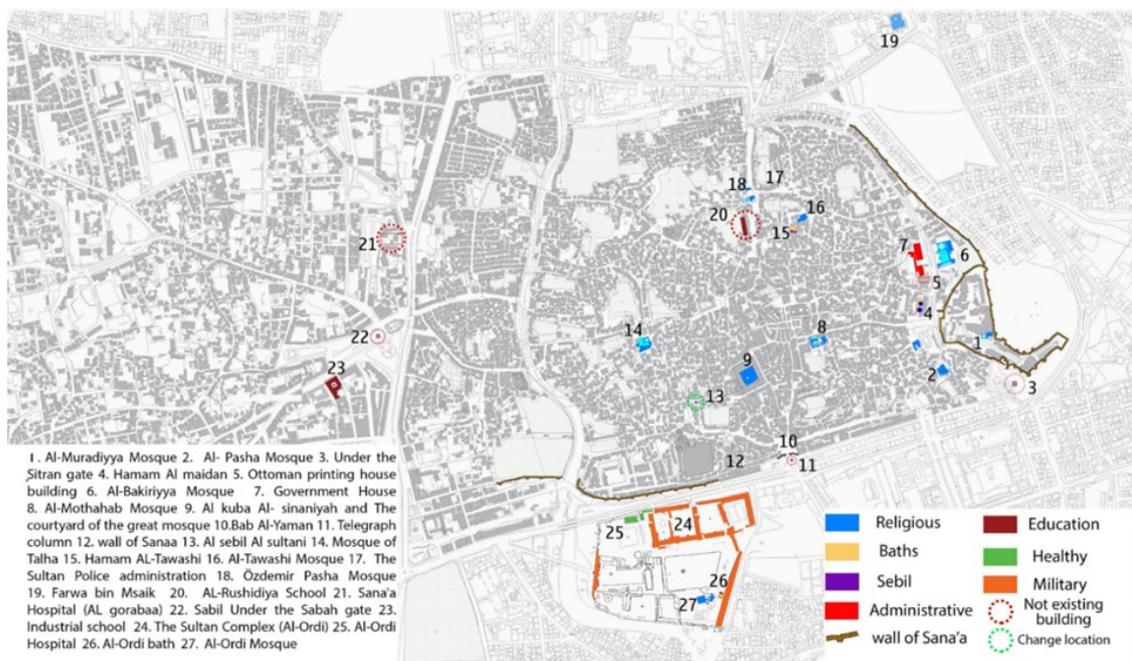
Figure 1. Map of old Sana'a shows Ottoman Structures

There are many buildings and archaeological sites in Sana'a, and there is no doubt that they represent a sincere architectural production that expresses the civilizational stage that the city of Sana'a went through during that period[6]. Despite the historical importance of these facilities, they did not find the necessary attention. Instead, they suffered from deterioration and neglect and destruction. Instead, they suffer decline, abandonment, and destruction. Thus, this study was conducted on the Ottoman building in Sana'a. Ottoman cultural heritage was surveyed and classified through a specific methodology: Functional type of origin and the arrangement of the building according to the date of construction. In addition to who built it and the current state of the building, does it still exist or not exist? Buildings that do not exist were identified through the sources that mentioned this phenomenon or through old photographs and maps. Through the field survey, it was compared to reality, identified on the map, and classified in the table. It is illustrated in Table 1 and is identified on the map (Figure 1).

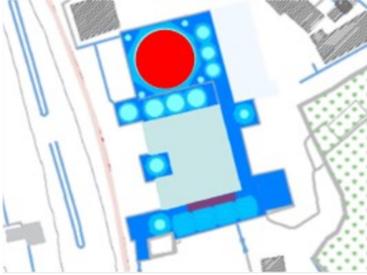
Structure	Location of Damage
1. Al-Bakiriyya Mosque

<p data-bbox="845 622 1145 645">LOCALIZATION OF DAMAGE</p>
2. Al-Ordi Complex

Structure	Al-Bakiriyya Mosque	Al-Ordi Complex	Government House	Hammam Al maidan	Al sebil Al Sultani
Type	Ottoman Mosque	Ottoman military facility	Ottoman military facility	Ottoman Hammam	Ottoman Sabil
Damaged sections	Domes	Gates, The Western Qishla, The second Qishla and Hospital	The old and new building	none	Wall
Cause of damage	Rain and other weather factors.	Effects of war: aerial bombardment, projectile holes, shrapnel	Effects of war: aerial bombardment, projectile holes, shrapnel	Rain and other weather factors.	Rain and other weather factors.
Kind of damage	Falling off the outer plaster of the domes and the tank.	Significant damage	Significant damage	Falling off the outer plaster of the domes.	Cracks in the bearing walls and falling some stones.
Scope of damage	In general, minor surface damage	The building was severely damaged, partially collapsed, and destroyed by the aerial bombardment. Loss of components or building elements detach from the building and fall off.	The building was severely damaged, partially collapsed, and destroyed by the aerial bombardment. Loss of components or building elements detach from the building and fall off.	In general, minor surface damage	In general, minor symptoms

Condition Class	No symptoms <b>CC1</b>	Major symptoms <b>CC4</b>	<b>(CC3)</b> Major symptoms	No symptoms <b>CC1</b>	No symptoms <b>CC2</b>
Urgency Class	from 3 years <b>UC1</b>	Short term, within 1 year <b>UC3</b>	<b>(UC3)</b> Short term, within 1 year	from 3 years <b>UC1</b>	from 3 years <b>UC2</b>
Recommendation class	<b>(RC1)</b> No measures	<b>(R.C. 4)</b> Major intervention based on diagnosis	<b>(RC4)</b> Major intervention based on diagnosis	<b>(RC1)</b> No measures	<b>(RC2)</b> Maintenance

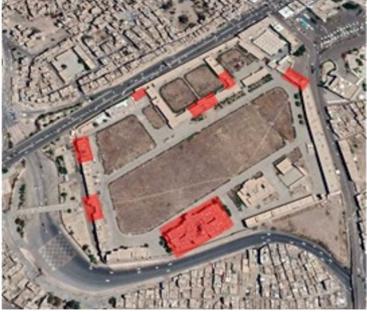
<p data-bbox="829 721 949 817">LOCALIZATION of DAMAGE</p>
3. Government House (National Security Building)

As a result of this analysis, most of Ottoman facilities in the old city of Sana'a are in good condition and need long-term maintenance within the assessment (RC1). However, two of these buildings, Mosque of Talha (Qubbat Talha) and Al sebil Al Sultani (Sabil Al-Abhr), require moderate maintenance under the RC2 classification. Also, Al-Ordi Complex and Government House (National Security Building) were

directly threatened and destroyed by aerial bombardment in 2015 Therefore, it needs basic repair and reconstruction within the RC4 classification.

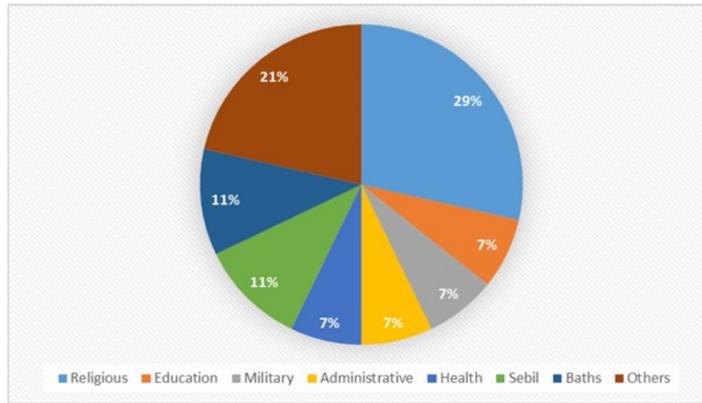
Figure 2. Categorized Ottoman structures by type

were enumerated in the old city of Sana'a, categorized by type into different fields (Figure2), of which twenty-one are currently in existence, of which one has been relocated to another location. Of the buildings that were counted in the city, seven were no longer present and were demolished after Ottomans left Yemen.

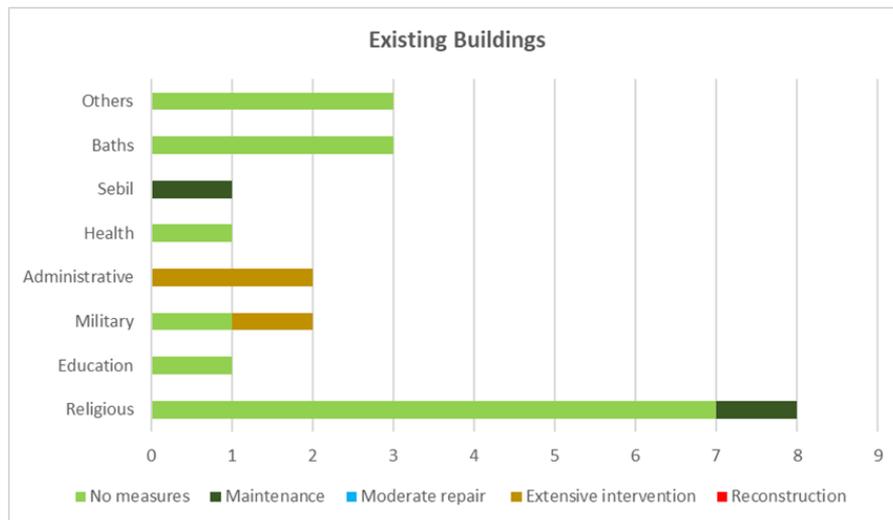
Figure 3. Recommendation of rehabilitation based on number of buildings, type, levels of damage and type of intervention

The previous analysis gave an overview of the extent of the damage and the priorities for the intervention. However, to achieve more accurate results, it was necessary to obtain accurate figures of the damaged structures, their type, and the level of intervention

(Figure3). Therefore, tables and figures relating to the type of buildings damaged, according to their number and levels of damage, have been prepared to make the process more realistic and achievable.

Through analysis, existing buildings endangered two of them during the last war. They were directly affected by aerial bombardment and needed urgent intervention to protect them. The rest of the buildings, although affected by various weather factors, especially the torrential rains that hit the city during the last two years, are in good condition and need medium or long-term protection.
