## ARCHITECTURAL STUDY OF KOCA SINAN PASHA MOSQUE AT KAÇANIK, KOSOVA

Koca Sinan Pasha Mosque is one of the oldest classical mosques built in Kosovo during the reign of the Ottoman Empire (1389-1912). The mosque bore the name of its donor and was completed in 1594/95. It is located in a small town in the southern part of the country, in Kaçanik. Regarding its compositional scheme, the monument belongs to the examples of Ottoman-style mosques in the Balkans with local elements. Its compositional scheme comprises a prayer hall, portico, and a minaret. The paper focuses on a brief history of the Koca Sinan Pasha, the history of the mosque, architecture, pictorial and sculptural decorations, current condition, and the monument's surroundings. By doing so, the paper helps identify the challenges that the mosque faced during its existence, as well as changes in the structure of the building and its decorations that occurred with time. The study relies on the existing monument as the primary source of information. However, the documentation of the Institute for the Protection of Cultural Monuments of Kosovo and the relevant literature that directly or indirectly deals with the issue in qu

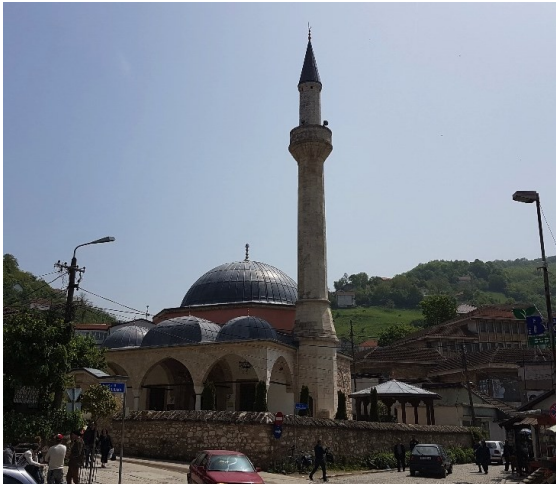
Figure 1: Koca Sinan Pasha Mosque

Kaçanik is a small town located in the southern part of Kosova, 35km from Skopje, the capital of Northern Macedonia. On the left side of the Lepenc River, in the former center of the Old Bazaar in Kaçanik is the Islamic religious building known as the Mosque

of Koca Sinan Pasha. (Figure. 1) We emphasize the former Old Bazaar because from this craft and trade complex, dating from the 10th decade of the XVI century, nothing remains from the initial state of construction. It is interesting to note that in front of the mosque, on the right side of the river Lepenc are the ruins of the ancient castle of Kaçanik.

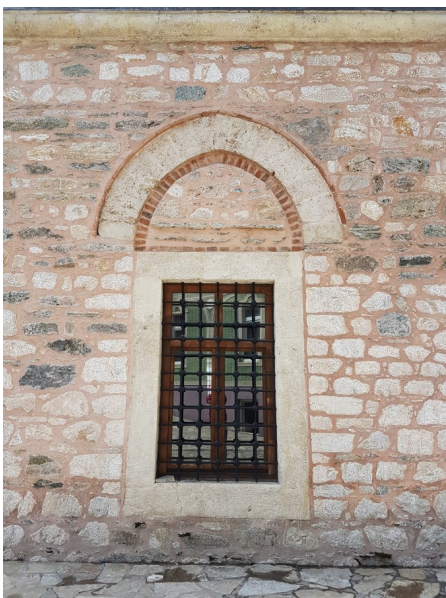
Figure 5: Koca Sinan Pasha Mosque. Window detail.

The volume and space of the prayer hall are illuminated and ventilated by a total of 12 windows. In each view of the facade, we have two windows covered with architraves and a tympanum. Windows have moldings, whereas the blind tympana stand out with its modest decorations with bricks. They are secured with knotted grills. (Figure. 5) Four other windows are constructed on the drum. The drum is octagonal shaped. On every second page of the drum, there is a window. This form represents a single and unique variant in mosque construction in Kosova's territory. The cornice of the prayer hall and the drum are also unique. The cornice is constructed of many stone pieces in convex shapes. (Figure. 6) As constructive and functional elements of the interior of the prayer hall are *mihrab*, *minbar*, and *mahfil* (gallery).

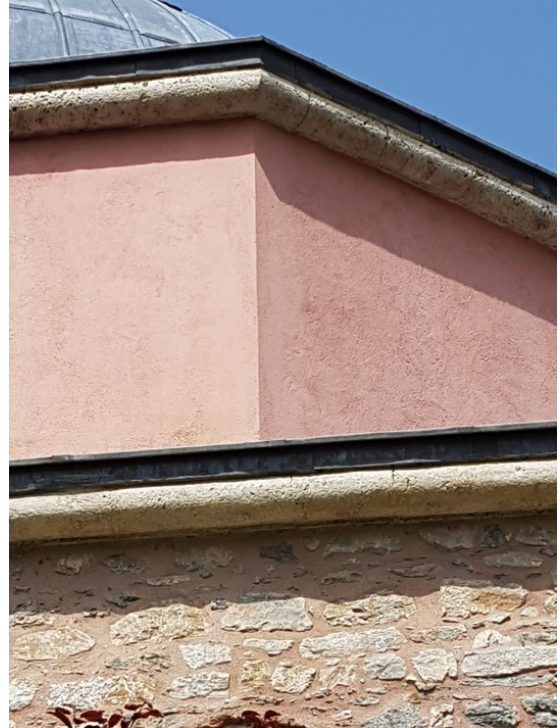
Figure 6: Koca Sinan Pasha Mosque. Cornices.

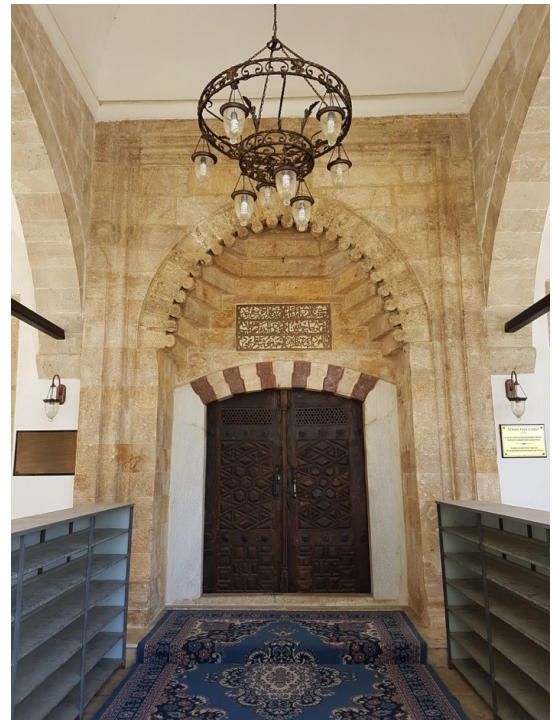
Figure 7: Koca Sinan Pasha Mosque. Portal.

The portal stands out with its historical and artistic importance and values. Above the entry door, are the mosque's inscriptions. This decoration is realized in middle relief sculpture. It is unique and represents an innovation on the portals of classical mosques in Kosova and the region as well. The gate of the portal is made of wood and decorated with geometric motifs. (Figure. 7)

Apparently, the portal can be a free expression of the master who built it. Or, it might be the influence of the craftsman who may have done work in any of the areas that Sinan Pasha served and built. Nevertheless, this is only an assumption; to date, we have not encountered any evidence to substantiate this assumption. However, it is known that during Ottoman rule, craftsmen from these areas took part in construction activities in regions and other centers of the Empire [30]. The portal in the region's mosques and many other mosques on the outskirts of the Empire was among the main parts where the direct communication of the building with its users and visitors took place [20]. Therefore, considering the construction's size and modesty, the portal as a constructive-architectural element plays an important part and gives a unique look to the building.

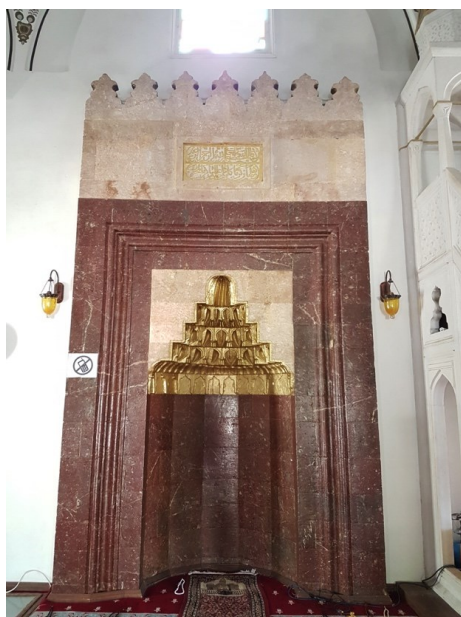
Figure 8: Koca Sinan Pasha Mosque. Mihrab.

*Mihrab*, as a constructive and functional element of the prayer hall, is made of marble. It serves to orient believers in the direction of Mecca. The opening of the *mihrab* has six angles and the upper part ends in a five-step pyramid shape. The upper part is decorated with stalactites. The *mihrab* is set in a rectangular frame. The frame is decorated with moldings that slightly project into the mosque's interior, Quran inscriptions, and seven tulip decorations. (Figure. 8)

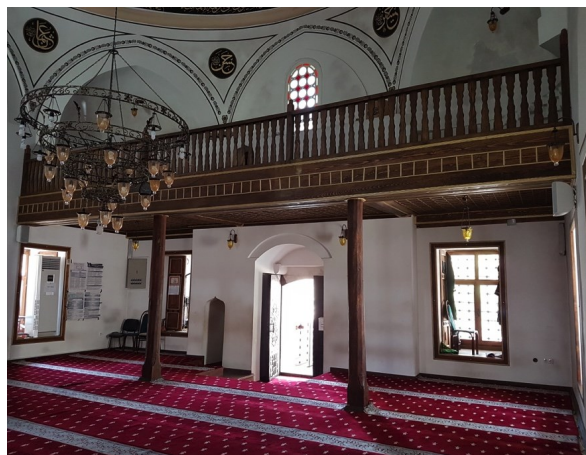
Figure 10: Koca Sinan Pasha Mosque. Mahfil (gallery).

The *mahfil*, as a constructive and functional element, serves and is used by the female gender. It is made of wood and supported by two wooden pillars and three sidewalls. (Figure. 10) Communication with the *mahfil* is possible with the help of the doorway located on the western wall. *Mahfil* is protected with wooden handrails.

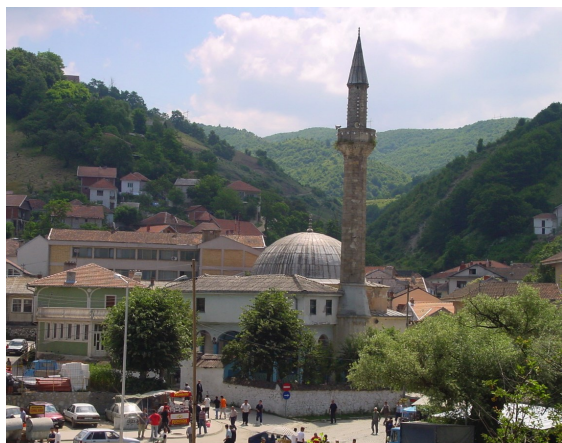
Figure 11: Koca Sinan Pasha Mosque. Old portico.

According to the photo documentation, the portico (narthex) of the mosque in its previous condition was open and made of wood [23][29]. It had a mono-pitched roof covered in the lead. Later, a closed narthex was added above the roof. This closed space was connected with the mosque through *mahfil* [3]. (Figure 11)

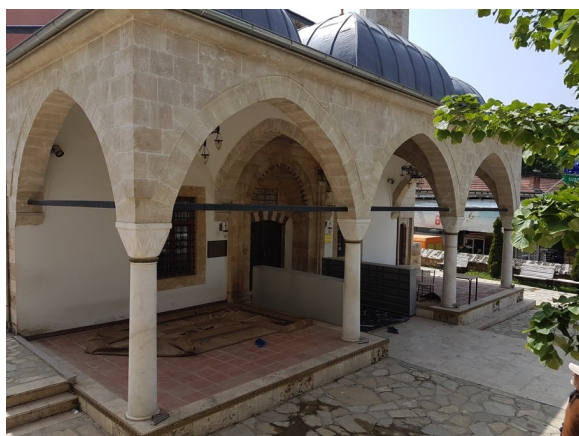
Figure 11: Kocan Sinan Pasha Mosque. Portico.

With this unprofessional intervention without any restoration criteria, the mosque was degraded. Now the portico has been reconstructed according to Ayverdi's architectural visualization. This type of portico is typical for the classical mosques in Kosovo. It is all made of regular rectangular stone. The portico has four pillars and arcades. The pillars have no base. They are circular. The capitals are decorated with geometric figures. The portico is covered with three smaller domes. (Figure. 11)

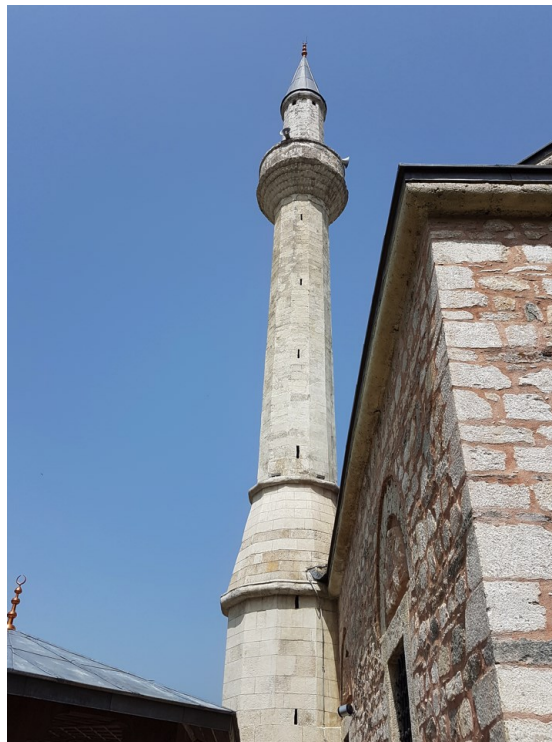
Figure 12: Koca Sinan pasha Mosque. Minaret.

The minaret is a compositional part of the mosque. It is situated on the right side of the praying hall. A constructive and functional element is polygonal and fully constructed from stone. Its footing is square, while other parts like the pulpit, transitional segment, and shaft, are polygonal. The base, pulpit, and shaft are regular rectangular stones. It has one balcony with five cornices decorated with stalactites. Unfortunately, stalactites are in bad condition. The tracery of the balcony is realized with stone slabs. The spire has a wooden construction and is wrapped in lead. The minaret, as in other mosques, has small openings for ventilation and lighting. The openings start from the base and continue to the top of the minaret roof.

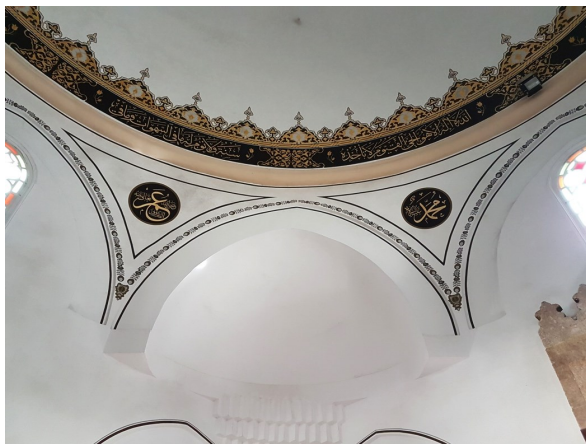
Figure 13: Koca Sinan Pasha Mosque. Decoration.

The interior of the mosque features paintings, medallions, and arabesque decorations. During the restoration works, it was intervened in the original mural painting. Apart from having new elements not of the initial time, the mural painting has also lost its originality [3]. The painting in the tempera technique is realized in dry plaster (*al secco*). The motifs, as in other works of Islamic religious character, are from the plant world, geometric figures, and quotations from the Qur'an. From the decoration, a medallion on the dome stands out. It is painted on the upper part, respectively, on the center of the dome. In the center, it has *thuluth* calligraphy and palmette motifs surrounding it. (Figure. 13) Apart from the dome, paintings mainly take place on the windows, squinches, and drums. (Figure. 14) The two-dimensional painting has a white background. The predominant colors are blue, purple, ochre, black and gray.

It should be noted that not every intervention in the building or its surroundings was done correctly and professionally. It can be witnessed in the interior decorations and the monument's external environment. After the restoration in 2012, the old paintings with floral motifs were removed. Floral motifs decorated parts above windows above the portal and on the drum. The dominating colors were light blue in windows, doors, squinches, and domes, whereas the mihrab frame was painted light green. Even though they were quite modest, decorations with light colors on a white background were typical for classical domed mosques in Kosova. Today, the white color still dominates the entire mosque. However, the decoration on the dome is totally new in a dark color and does not correspond with previous mosque painting traditions in Kosova.
