## **IMPROVED ACCESSIBILITY FOR PEOPLE WITH DISABILITIES AT THE SHEIKH ZAYED GRAND MOSQUE USING A UNIVERSAL DESIGN APPROACH**

People with disabilities must be considered as one of the Sheikh Zayed Grand Mosque user groups. This happens because of the lack of accessible facilities and it is not in accordance with the standards set by the government. Therefore, it is necessary to conduct a research to determine whether the Sheikh Zayed Grand Mosque has met the accessibility criteria. The research aims to determine the accessibility of the Sheikh Zayed grand mosque. The results of the assessment are used as a basis for making improvements in the mosque accessibility. The method used is filling out an accessibility check sheet. The checklists are developed from the regulation of the Minister of Public Works and Housing of the Republic of Indonesia number 14/PRT/M/2017 and universal design. The level of accessibility is also determined based on the same regulation and universal design. The areas studied include: circulation/corridor, entrance/exit, ramp, stair/lift, handrail, wudu area, toilet, prayer room, parking area, as well as signs and information. The results of the accessibilit

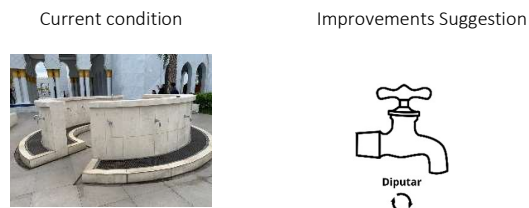
Figure 5. *Wudu* room conditions are not uniform

Using the seven criteria, it is shown that that five criteria are accessible, one criterion is less accessible, and one criterion is not accessible. The non-accessible criteria are the uniformity of facilities in the *wudu* area, and 1 less accessible criterion is that the faucet is not easy to use. The picture below is one example of the inconsistency between the *wudu* room in the park, and inside the mosque with the presence of the faucet usage instructions sticker on the *wudu* room inside. With this, it was found that some visitors were still confused about using the *wudu* faucet in the mosque garden because there were no instructions for using it.

Referring to Universal Design Handbook [6] about Equitable Use, the definition of this term is providing the same means of use for all users, identical whenever possible, or at least equivalent. So, it is recommended to standardize existing facilities to give the impression of neat and helpful for first-time visitors and less menau-related procedures for using *wudu* facilities provided.

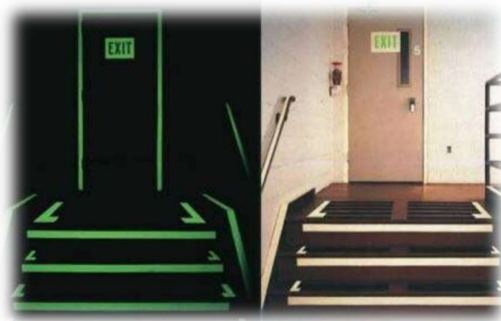
Figure 13. (A) when it is dark (b) when it is normal

The use of color displays must also be considered in its application, it is essential to prevent a blurry or unclear effect when the letters are read from a normal distance of at least 2 m. The use of a good color display is according to safety standards as shown in the Figure 13-16.
