## **REHABILITATION OF DOMED MOSQUES FROM THE OTTOMAN PERIOD IN BOSNIA AND HERZEGOVINA: THE CASE OF FERHAD PASHA MOSQUE**

The paper explores the role, significance, and validity of the post-war rehabilitation of Ottoman-era domed mosques in Bosnia and Herzegovina, focusing on the case of the Ferhad Pasha Mosque in Banja Luka. After the end of the war, various forms of reconstruction were undertaken, and the most common method was complete (facsimile) reconstruction, known as post-war rehabilitation of architectural heritage. These rehabilitation projects, across various public and religious buildings, include the renovation of mosques as an integral part of the refugee return project and the promotion of coexistence and reconciliation among different communities in BiH. Special attention from the profession and the public has been placed on the rehabilitation of domed mosques from the Ottoman period, as objects that have already been recognized and declared national monuments. During the research, the question arises: Does rehabilitation affect the authenticity of architectural heritage? What does the post-war rehabilitation of architectural heritage actually mean, and what method

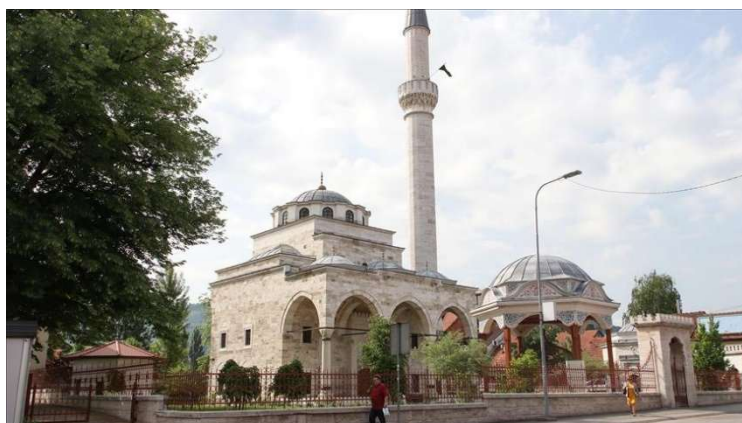
Figure 2. Ferhadija Mosque after reconstruction

The significance of the Ferhadija Mosque (Figure 2) is reflected in the values that constitute a testimony to a certain type, style, or regional manner of this architectural heritage. The contemporary layout and construction of the Ferhadija Mosque, with all its values, puts the main place of worship in Banja Luka at the top of the scale of Islamic religious buildings in the Balkans. The harmony, proportions, and architectural volumes are enriched by the emphasis on the verticality of the building. The classic Ottoman style is reflected in the fact that all the building's elements, not just the minaret, have tall, slender forms, in which the dynamics and importance of each element are simultaneously emphasized[15]. The unique compositional unit, which tends to be pyramidal in shape, is actually made up of parts of the object, each of which stands out with its own individuality. It is precisely this composition, proportions, and specific construction that highlight artistic and aesthetic values, which are complemented by the quality of materials and workmanship, as well as the value of details [14]. Symbolic value is essential for religious objects. The motive for the rehabilitation of this architectural heritage is reflected in the need to obtain sacred space, affirmation, i.e., the restoration of national identity after the war, and the restoration of a valuable monument that embodies traditional values. The Ferhadija Mosque also has a crucial ambient value for the city of Banja Luka. Since its inception, it has been the central building in Banja Luka's city center. As such, it is significant in the image and structure of the city. If we take into account the position and location of the Ferhadija Mosque, its shape and design, the tradition and construction technique, materials, content, purpose, and continuous use, we conclude that it is truly a superb architectural work, a rare example of a certain style with values such as uniqueness and representativeness.

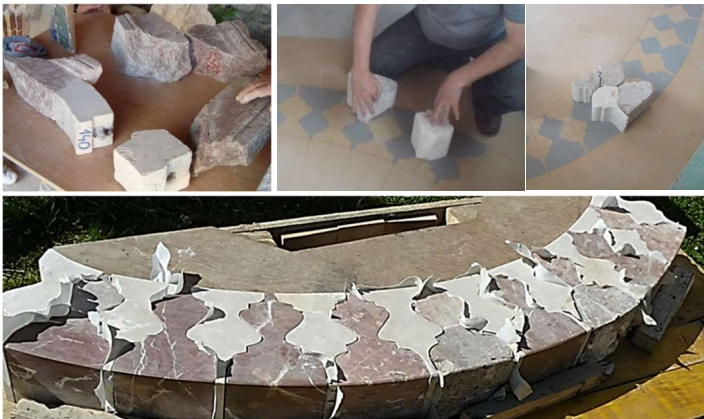
Figure 3. Making and preparing floral elements of the segmental arch of the mosque portal (A) (B) (C) (D)

The entrance portal of the mosque (Table 4), as the most representative element, features a richly profiled tufa frame that terminates at the top with a cornice bearing smaller and larger trefoil motifs. The door side jambs are made of red limestone, connected by a segmental arch consisting of 19 floral motifs, alternately set in darker and lighter shades of red limestone. Above the door are two stone slabs. The first slab is narrow and has the prayer text carved on it, while the second slab is a stone inscription with information about the construction of the mosque. The entire space of the entrance portal is ultimately framed by two tufa arches, the lower of which is flush with the wall, while the upper is protruding. After searching for the remains of the mosque, parts of the floral motifs that make up the portal arch were found. The extent of their damage was great. After cleaning and restoration, only parts of the 5 floral motifs could be reinstalled. A 1:1 scale arch template with floral elements was created in the workshop, based on which the missing elements were made (Figure 4 A.B.C.D). The stone blocks were cut by machine, as was the rough preparation of the elements. This was followed by transferring the shapes from the templates and by hand-finishing.

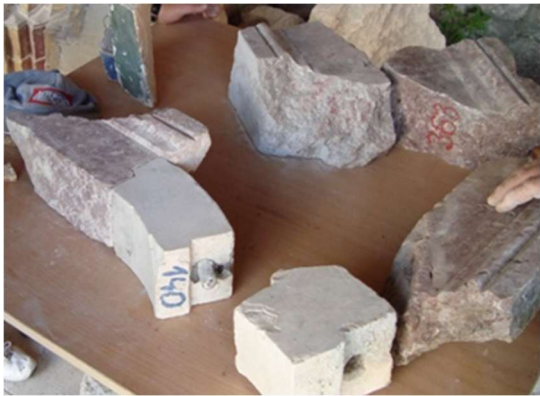
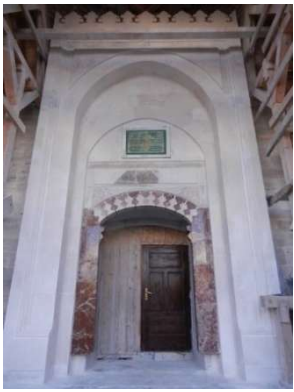
Table 4. Level of damage and methods of protection applied to the entrance portal

| Building segment: The entrance portal | | | | | | |
|---|---|---|---|---|---|---|
| Degradation level | Original appearance data | | Applied protection methods | | Used materials | |
| No damage | Existing | | Anastylosis | ✓ | Same material | Traditional ✓ |
| Minor damage | Limited | ✓ | Conservation | ✓ | Same-source material | ✓ Modern construction techniques |
| Medium-level damage | Unreliable | | Restoration | ✓ | Replacement material | ✓ Traditional and modern construction techniques |
| Severe damages | ✓ Non-existing | | Reconstruction | ✓ | Contemporary materials | |

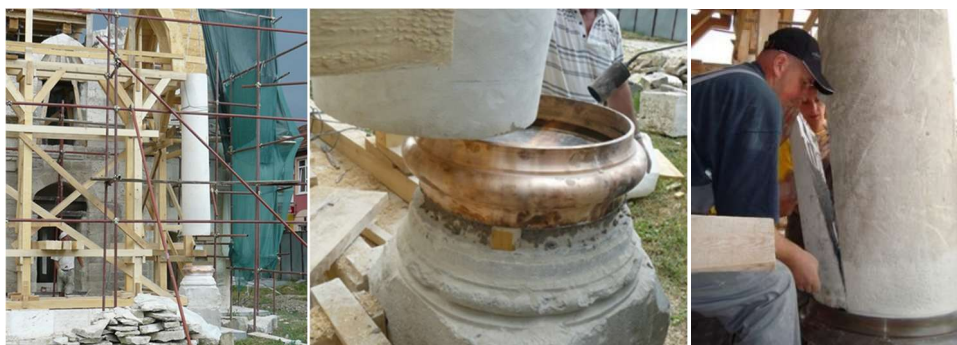
Figure 4. Installation of restored porch pillars  
(A) (B) (C)

The porch is formed by four round stone pillars connected by pointed arches. The capitals of the columns have stalactite and geometric forms. The two inner columns have stalactite motifs on their capitals, while the two outer columns are decorated with geometric shapes, specifically rhomboids. The search for fragments of the mosque and their processing led to the discovery of a large number of pillar fragments. After cleaning, the following damages were found: scratches and fractures caused by the demolition of the mosque. The decision was made to make two external pillars out of the found fragments that met the conditions for reinstallation, while the other two pillars were newly built. The first step was cleaning, i.e., washing the found fragments with water and applying a coating to improve the adhesion of the stone mixture (stone flour). The so-called stone flour was made from grinded fragments, which were extremely small in size, in the sense that they could no longer be used and/or their position could not be determined. Grinded fragments are used to create a stone mixture that further fills the cracks of larger elements. Surfaces treated in this way are manually sanded and smoothed in order to bring the applied mass to the same level as the surface of the original fragment. In the same way, the rehabilitation of four stone pedestals, as well as four pillar bases, was carried out, as shown in Figure 5. The level of damage and the methods of protection applied to the porch pillars are shown in Table 5.

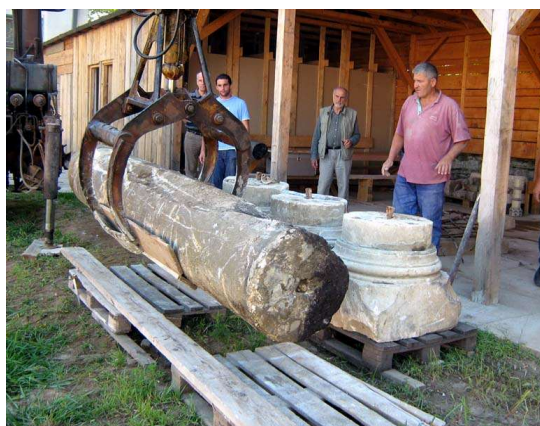
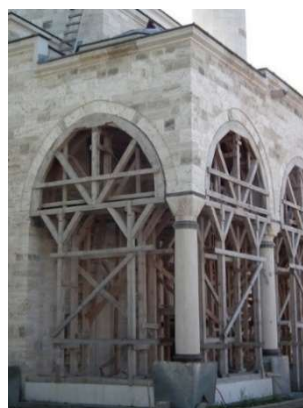
Table 5. Level of damage and methods of protection applied to the porch pillars

| Building segment: The porch pillars | | | | | | | |
|---|---|---|---|---|---|---|---|
| Degradation level | Original data | appearance | Applied methods | protection | Used materials | Construction techniques | |
| No damage | Existing | ✓ | Anastylosis | | Same material | ✓ | Traditional ✓ |
| Minor damage | Limited | | Conservation | ✓ | Same-source material | ✓ | Modern construction techniques |
| Medium-level damage | ✓ Unreliable | | Restoration | ✓ | Replacement material | | |
| Severe damages | Non-existing | | Reconstruction | ✓ | Contemporary materials | | Traditional and modern construction techniques |

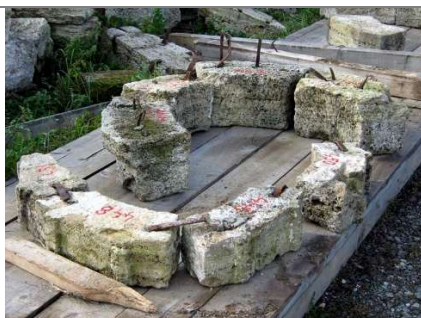
Table 6. Level of damage and methods of protection applied to the mosque tower

In 2008, construction of the minaret began. According to the rehabilitation project, it was planned that all necessary replacement stone for the restoration of the Ferhadija Mosque would be obtained from the same quarry as the original stone used in its construction; however, this was simply not possible. Although the quarry was located near Banja Luka, in Sitari, its exploitation was impossible, so a replacement stone had to be found. The replacement stone for the minaret restoration of the mosque was travertine from Armenia, which, after analysis, was found to be the most similar to the original stone. The second important step in constructing the minaret was ensuring its stability. Devastating earthquakes that hit Banja Luka in 1969 and 1981 showed the extreme vulnerability of this slender structure. The first earthquake caused the upper part of the minaret (all above the balcony) to collapse. This was followed by a repair, in which the upper part of the minaret was made of reinforced concrete and covered with stone. This inadequate intervention only preserved the upper part of the minaret's shaft, while the lower part, although stressed and damaged, was neglected. The shortcomings of such incomplete work were highlighted during the 1981 earthquake that hit the Banja Luka area. This earthquake caused significant damage, most pronounced in the form of cracks. The rehabilitation and restoration work, which were preceded by recording the dynamic state of the building, were carried out in 1989. The weakened core of the minaret was repaired by installing 8 ribbed bars ( $\varnothing 19$ ) positioned in vertical slots (5x5cm) drilled on the inside of the minaret wall [15]. The connection between the ribbed bars was achieved with special inserts and threads, while welding was carried out only in the lower part of the minaret, i.e., in places where the vertical bars passed through the reinforcement of the concrete part of the minaret, as illustrated in Figure 6. Having learned the lessons of the past, it was decided that the post-war rehabilitation project for the Ferhadija Mosque would apply the same methods to ensure stability as those used in 1989 [13], [14], [32]. The level of damage and methods of protection applied to the mosque tower are shown in Table 6.

| Building segment: The mosque tower (minaret) | | | | | | | |
|---|---|---|---|---|---|---|---|
| Degradation level | Original appearance data | | Applied protection methods | Used materials | | Construction techniques | |
| No damage | Existing | ✓ | Anastylosis | Same material | ✓ | Traditional | ✓ |
| Minor damage | Limited | | Conservation | Same-source material | ✓ | Modern construction techniques | |
| Medium-level damage | Unreliable | | Restoration | Replacement material | ✓ | | |
| Severe damages | ✓ Non-existing | | Reconstruction | Contemporary materials | ✓ | Traditional and modern construction techniques | ✓ |

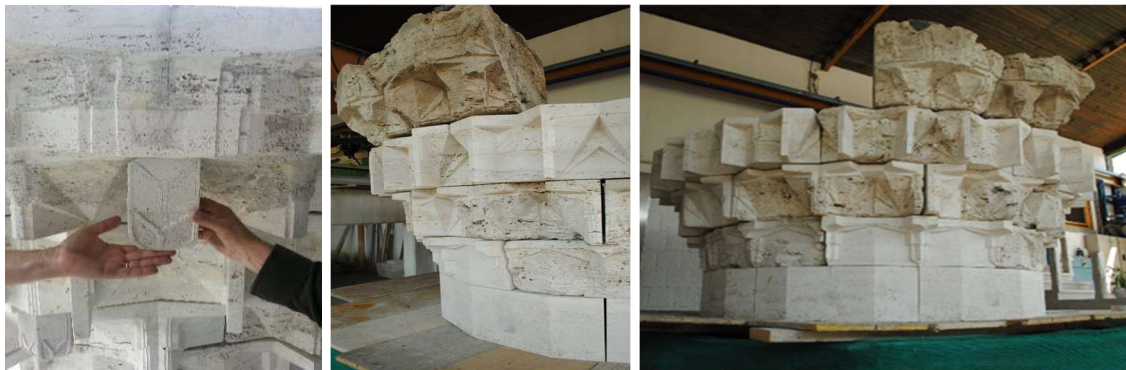
Figure 6. Şerefe parts in the workshop, assembling new and restored parts  
(A) (B) (C)

An examination of the fragments of the minaret balcony revealed that over 50% of the original stone can be reused, while the rest needs to be remade. This meant providing the same or replacement stone, carving and shaping new elements according to the model of the existing ones. It was necessary to subject the existing elements to restoration-conservation works and shape them in the context of the place where they were installed, and in the context of the fragment where they were installed. The new stone elements were made of travertine, and the connection with the other stone elements was achieved with iron spikes cast with lead. On the upper side of each stone row of the balcony, clamps were placed, which were also cast with lead. After installing all the elements, on-site fine processing was carried out, for which a special scaffold was constructed, as illustrated in Figure 7. The Level of damage and methods of protection applied to the minaret balcony are shown in Table 7.

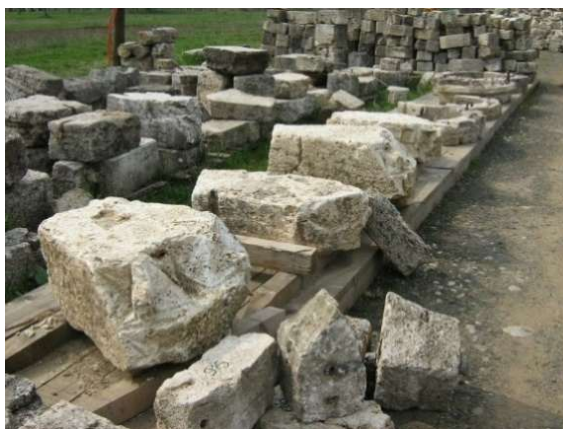
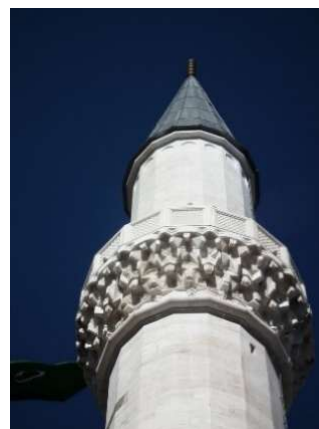
Table 7. Level of damage and methods of protection applied to the minaret balcony

| Building segment: The minaret balcony (şerefe) | | | | | | | |
|---|---|---|---|---|---|---|---|
| Degradation level | Original data | appearance | Applied methods | protection | Used materials | Construction techniques | |
| No damage | Existing | | Anastylosis | ✓ | Same material | ✓ | Traditional ✓ |
| Minor damage | Limited | ✓ | Conservation | ✓ | Same-source material | Modern construction techniques | |
| Medium-level damage | Unreliable | | Restoration | ✓ | Replacement material | | |
| Severe damages | ✓ | Non-existing | Reconstruction | ✓ | Contemporary materials | ✓ | Traditional and modern construction techniques |

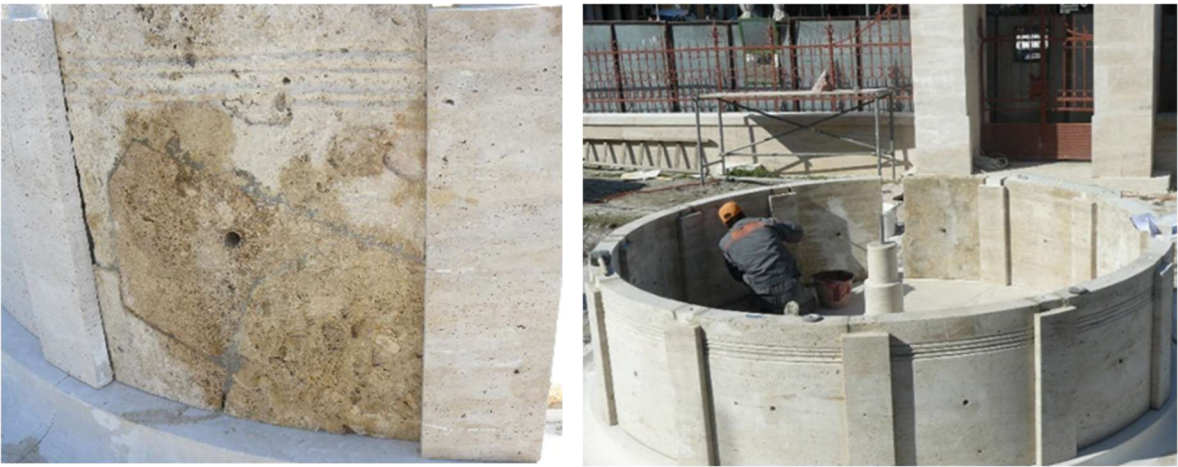
Figure 7. Restoration of one and reconstruction of the other elements of the fountain (A) (B)

During the foundation restoration and ground preparation for the installation of the fountain base, stone elements were found at a depth of about 40 centimeters. Their analysis led to the conclusion that these were elements of a fountain that was removed and rebuilt during the Austro-Hungarian period. The Feradija Mosque rehabilitation project had previously defined these elements based on written and photographic documentation from the Austro-Hungarian period, meaning that the base, as well as the twelve segments that make up the fountain, were made of Hreša stone, as confirmed by the discovery of fragments in dumpsites. There was no information about the earlier fountain, so this discovery was of great importance. The stone elements found in the ground were first cleaned, selected, and analyzed. It was concluded that they were broken pieces of twelve segments of the fountain, and it was decided to install these newly discovered fragments. These elements were not made of Hreša stone, as mentioned earlier, but of travertine, and the project changed accordingly. The rehabilitation of the found fragments resulted in the assembly of one whole element that was incorporated, and based on which the other eleven elements were made (Figure 8). The level of damage and methods of protection applied to the ablution fountain are shown in Table 8.

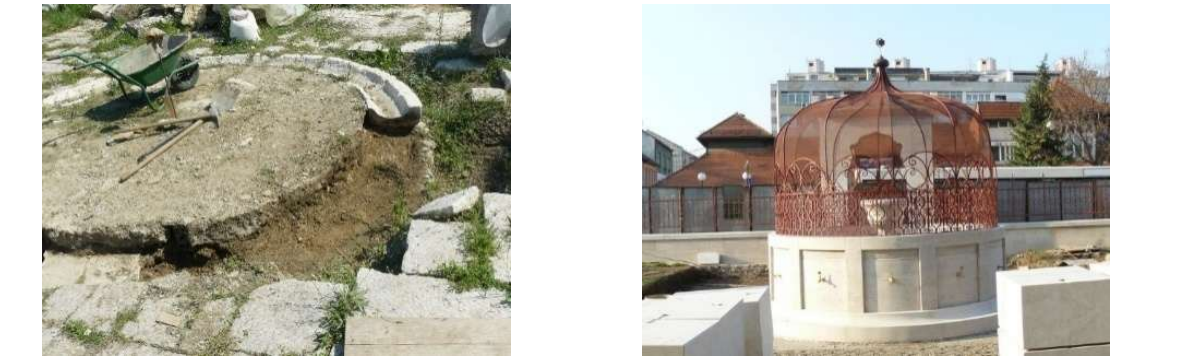
Table 8. Level of damage and methods of protection applied to the ablution fountain

| Building segment: The ablution fountain (şadirvan) | | | | | | | | | |
|---|--|---|--|---|--|---|--|---|--|
| Degradation level | | Original appearance data | | Applied protection methods | | Used materials | | Construction techniques | |
| No damage | | Existing | | Anastylosis | | Same material | | Traditional ✓ | |
| Minor damage | | Limited | | Conservation | | Same-source material ✓ | | Modern construction techniques | |
| Medium-level damage ✓ | | Unreliable | | Restoration ✓ | | Replacement material ✓ | | | |
| Severe damages | | Non-existing ✓ | | Reconstruction ✓ | | Contemporary materials | | Traditional and modern construction techniques | |
