# FORENSIC IDENTIFICATION OF THE VEHICLE IMPACT THAT LED TO THE COLLAPSE OF THE BUSUI BRIDGE STRUCTURE

**Abstract:** *This research presents a comprehensive forensic investigation into the structural failure of the Busui Bridge, a steel truss bridge in Kalimantan, Indonesia, following a catastrophic collision with a heavy vehicle. The study combines an on-site forensic audit with a simplified Finite Element Method (FEM) simulation to analyze the failure mechanism. This analysis evaluates the structural integrity of a steel truss bridge using stress data from a provided image. The maximum longitudinal stress value of  $3.402 \times 10 \text{ kN/m}^2$ , which converts to 340.2 MPa, was compared against the specified properties of BJ 37 steel, namely the yield strength ( $f_y$ ) of 240 MPa and the ultimate tensile strength ( $f_u$ ) of 370 MPa. The results unequivocally demonstrate that the applied stress has exceeded the material's yield strength. This indicates that the bridge has entered the plastic deformation range, resulting in permanent, irreversible damage to its members and a severe compromise of its overall structural integrity. The bridge is therefore determined to be in a

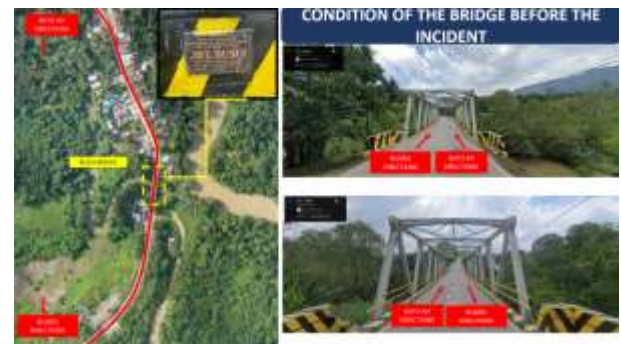
Figure 2. Condition of the bridge before the incident

The forensic investigation of the Busui Bridge began with a comprehensive on-site audit to document the pre-incident condition and the extent of the damage. The inspection confirmed the bridge's existing dimensions, which were a total length of 36 m and a width of 7 m (consisting of a 6 m roadway with 0.5 m shoulders on each side). The visual examination of the substructure, specifically the abutments on both the Kuaro and Batu Aji sides, revealed no evidence of cracking, shifting, or other damage, confirming they were in good condition and had not contributed to the failure.

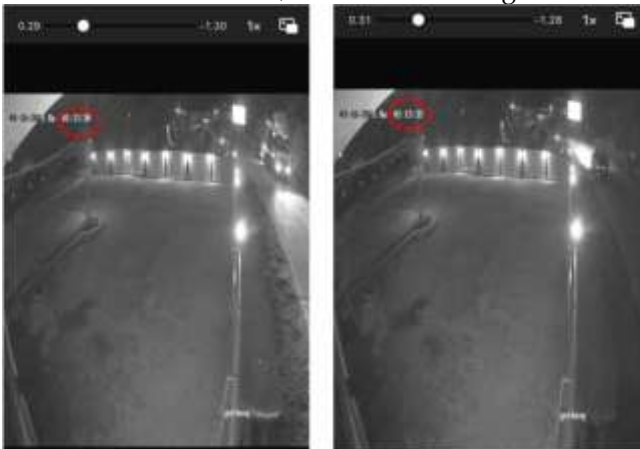
Figure 3. Vehicle speed simulation is based on CCTV video footage

This is then converted to a more common unit for traffic speed:  $v=10$  (m/s), if  $1 \text{ (m/s)} = 3.6 \text{ (km/h)}$ , then if the speed is  $10 \text{ (m/s)}$ , it becomes  $36 \text{ (km/h)}$ . This vehicle speed simulation is based on CCTV video footage from the scene of the incident, as shown in the figure 3.

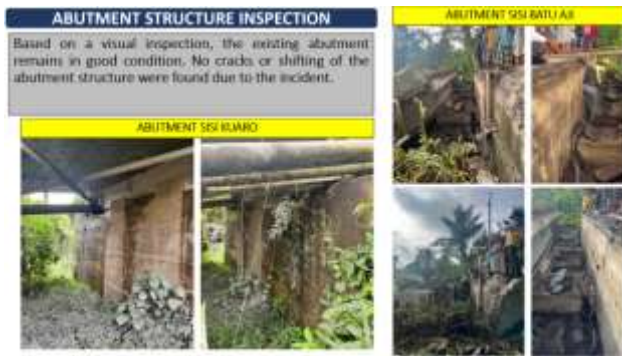
Figure 4. Abutment structure inspection

The documentation of the superstructure, however, revealed extensive and specific damage. The most significant finding was the "failure" and "tearing" of several gusset plates, particularly in the segments closest to the point of impact. This was accompanied by a clear change in shape ("perubahan bentuk") of the diagonal members and girders in the path of the vehicle, from the Batu Aji side of the bridge. The concentration of the damage to these specific, critical components strongly points to a localized failure mode. Based on a visual inspection, the existing abutment remains in good condition. No cracks or shifting of the abutment structure were found due to the incident, as shown in Figure 4.

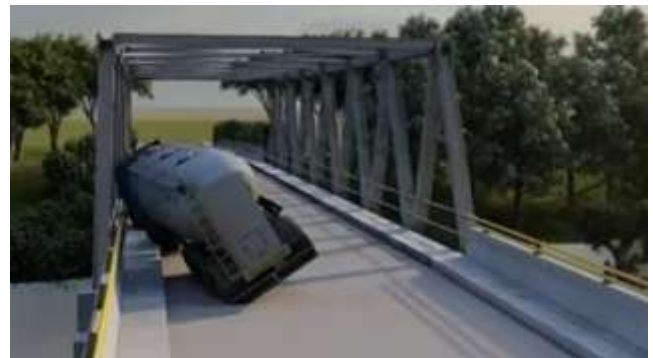
Figure 5. Simulation of heavy vehicle collision on the diagonal side of the bridge superstructure

Which equals approximately 4.84 m/s or 17.42 km/h. Therefore, after braking for 5 meters, the vehicle's speed reduces to about 17.42 km/h, as shown in Figure 5.

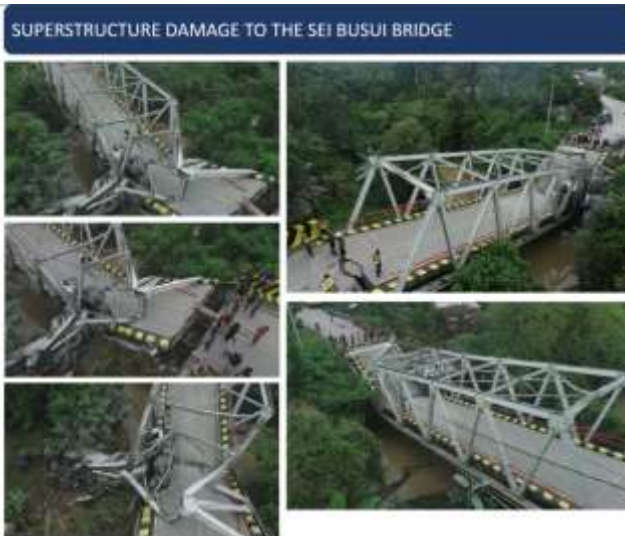
Figure 6. Superstructure damage to the sei busui bridge

The analysis demonstrates that the kinetic energy of a heavy truck, even at a low speed, is significant. When this energy is transferred to a structural component over a short deceleration distance, it generates an immense impact force. This force was concentrated on a diagonal member, a component integral to the truss's load-carrying function. The correlation between the calculated impact force and the observed physical damage—particularly the torn gusset plates—provides strong support for the conclusion that the dynamic load was the direct trigger for the collapse, as shown in Figure 6.

The Busui Bridge failure is a powerful, real-world illustration of a progressive or "disproportionate" collapse, where a small-scale, localized event triggers a widespread and catastrophic failure. The forensic evidence and dynamic analysis collectively suggest a clear failure mechanism. The vehicle impact was not a glancing blow, but a direct collision with a diagonal member of the truss, which was a critical, non-redundant component of the bridge's load-bearing system. This impact initiated a brittle failure at the gusset plate connection. The gusset plates, designed to distribute forces at the joints, were unable to withstand the concentrated dynamic load. Once these critical connections failed (tore), the structural integrity of the entire truss segment was compromised. The inability of the remaining members to redistribute the load led to a cascading collapse of the entire superstructure.

The short-term solution involves the installation of a temporary Bailey bridge. This is a strategic choice for emergency situations. Bailey bridges are prefabricated, modular steel structures that are renowned for their ability to be rapidly assembled and deployed with minimal heavy equipment, making them ideal for disaster relief and emergency infrastructure projects. They provide a rapid lifeline to restore traffic flow, minimize economic disruption, and reconnect the community. The implementation steps for this temporary solution are practical and focused on speed, including the quick evacuation of the damaged vehicle and the preparation of the site, such as ground surveys and coordination for utility relocation.

The long-term solution involves the construction of a new, permanent truss bridge. This approach prioritizes durability, increased load capacity, and lower long-term maintenance costs over the expediency of the temporary structure. The proposed implementation steps are more extensive, involving a detailed inspection of the existing abutments, a plan for repair if needed, and the fabrication and modification of a new steel truss. The new bridge is specified as a 35 m span, a slight but significant reduction from the original 36 m length. This discrepancy suggests a deliberate engineering decision, possibly to optimize the new design's structural performance, account for new abutment geometry, or improve overall constructability. The two-phase plan effectively addresses both immediate public safety and long-term infrastructure investment, serving as a best-practice model for responding to such failures.
