STRATEGIES TO INCREASE THE ACOUSTICAL QUALITY OF THE MOSQUES WITHOUT REINFORCEMENT SYSTEM

Ernaning Setiyowati

Jurusan Teknik Arsitektur, Fakultas Sains dan Teknologi, UIN Maulana Malik Ibrahim Malang, Indonesia
e-mail: ninkarch99@yahoo.com

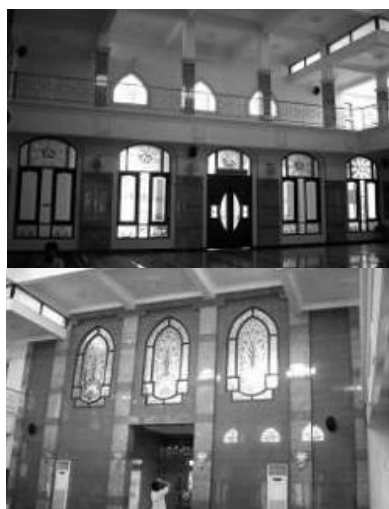
Figure 3. Interior of Masjid Nurul Iman

Meanwhile, Masjid Nurul Iman (Figure 3 - 4) is located at Margorejo Indah Estate, Surabaya. The south and the north side of this mosque is the highest source of noise, while the west side bounds with the residential buildings and the east side is

adjacent to the river. This mosque has a square plan form and dome ceiling form. The dimension of this mosque is 15 x 15 x 8 m³.

The largest part of this mosque's interior is the reflecting materials, which are marble floor, glass window, brick plester wall, ceramic tile on wall, and plywood doors. There is only 1/3 part of the floor that is covered by carpet. With that kind of composition material, it could be predicted that the mosque might have a bad acoustic quality because the reflected area is bigger than the absorbed area. The area of the opening is 8% of the wall area. It adds the area of reflected material⁸.

The biggest acoustic problem in Masjid Nurul Iman is the reflecting area and the dome ceiling that has caused the very huge reflected sound, especially inside the dome and then run straight to the center below the dome. That path of sound could raise RT value far above the standard and therefore cause a bad sound distribution.

The wide area of the reflection in Masjid Nurul Iman can be seen from the area covered by the carpet which only 1/3 area of the floor. Besides, the opening area was only 8% of the wall area. One thing could be done to decrease the RT value was by adding the absorbing area, such as covering the whole floor by carpet and covering the wall with an absorbing material. This area should be 26% of the wall area. If the area is too wide, it would decrease the RT value too low. Those absorbing materials could be replaced by the openings. The changing of the dome material by the absorbing material could also decrease the RT value.

To handle the sound distribution below the dome is by giving it a flat plane below it. The arrangement of these planes is just the same with the crown ceiling, which will direct the *imam*'s voice straight to the *jamaah* according to the theory of the path of sound inside the enclosed room. This strategy could distribute the sound to the whole room and also could reduce the RT value as well. If these thing were done, then the changing of the ceiling material should not be done. Because if all of the strategies were done, then the RT value will decrease too far below the standard. This is not considered as a good condition, because the sound will dissappear too quick before it can be heard by the *jamaah*.

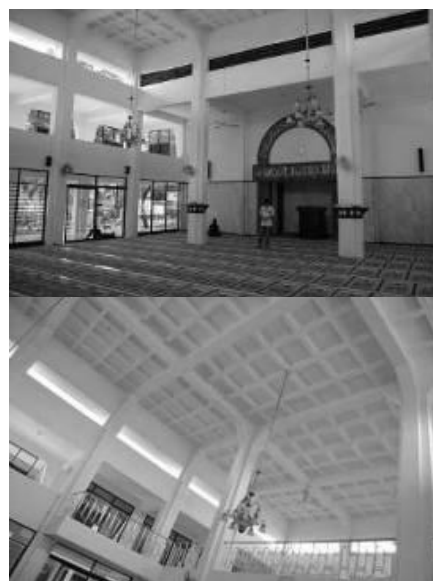
Figure 5. Interior of Masjid Baitussalam

Masjid Baitussalam (Figure 5) is located at Ketintang Madya Estate Surabaya. The location of this mosque is side by side with Baitussalam Junior High School and the main road that is the highest source of noise. The plan shape of this mosque is rectangle with the long side parallel to *kibla*. The ceiling shape is flat. The dimension of the mosque is 12,8 x 21,6 x 8 m³. The material of this mosque is a reflecting material, which are glass window, glass door, brick plester wall, and ceramic tile on the wall. All of the floor is covered by the carpet, so it could reduce the reflecting area. The opening area is 20% wall area. It also could reduce the reflecting area.

Masjid Baitussalam has an acoustic problem which is caused by its plan shape. It is rectangle with the long side parallel to *kibla*. The problem is the bad sound distribution and the high RT value.

The strategy to fix this problem is by adding the opening area or the absorption surfaces into 26% of wall area. To handel the sound distribution, the reflector could be used and arranged to direct the sound to the whole *jamaah*. This reflector could be arranged in the ceiling or walls.
