STRATEGIES TO INCREASE THE ACOUSTICAL QUALITY OF THE MOSQUES WITHOUT REINFORCEMENT SYSTEM

Ernaning Setiyowati

Jurusan Teknik Arsitektur, Fakultas Sains dan Teknologi, UIN
Maulana Malik Ibrahim Malang, Indonesia
e-mail: ninkarch99@yahoo.com

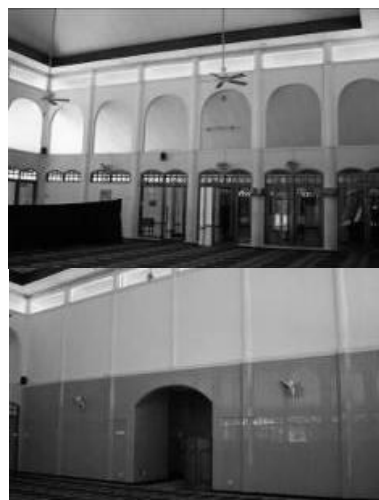
Figure 1. Masjid Al-Maghfirah's Interior

Masjid Al-Maghfirah is located at Rungkut Asri Estate Surabaya. This building is surrounded by residential buildings, except the south side that is exactly next to the road. This side is the highest noise source for the building. The plan shape is square (Figure 1 - 2), while the ceiling shape is crown. The mosque's dimension is 14,5 x 14,5 x 8 m³. The composition of materials in this mosque are some reflection materials, which are glass window, glass door, brick plester wall, and ceramic tile on wall. All area of the floor is covered by carpet. The area of opening is 23% of wall area, which could decrease the reflecting area.

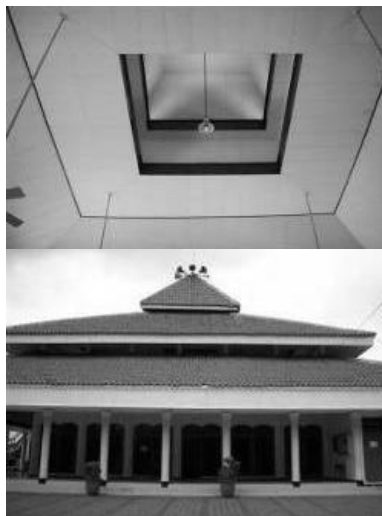
Figure 2. The ceiling (above) and exterior (below) of Masjid Al-Maghfirah

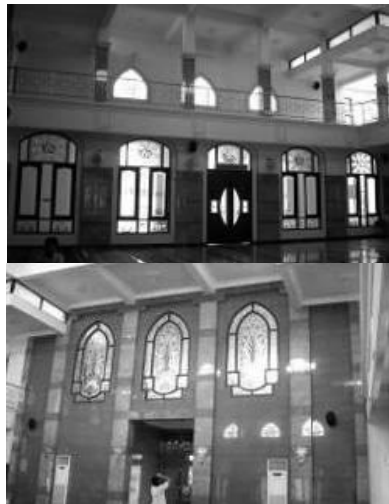
Figure 3. Interior of Masjid Nurul Iman

Meanwhile, Masjid Nurul Iman (Figure 3 - 4) is located at Margorejo Indah Estate, Surabaya. The south and the north side of this mosque is the highest source of noise, while the west side bounds with the residential buildings and the east side is

adjacent to the river. This mosque has a square plan form and dome ceiling form. The dimension of this mosque is 15 x 15 x 8 m³.

The largest part of this mosque's interior is the reflecting materials, which are marble floor, glass window, brick plester wall, ceramic tile on wall, and plywood doors. There is only 1/3 part of the floor that is covered by carpet. With that kind of composition material, it could be predicted that the mosque might have a bad acoustic quality because the reflected area is bigger than the absorbed area. The area of the opening is 8% of the wall area. It adds the area of reflected material⁸.

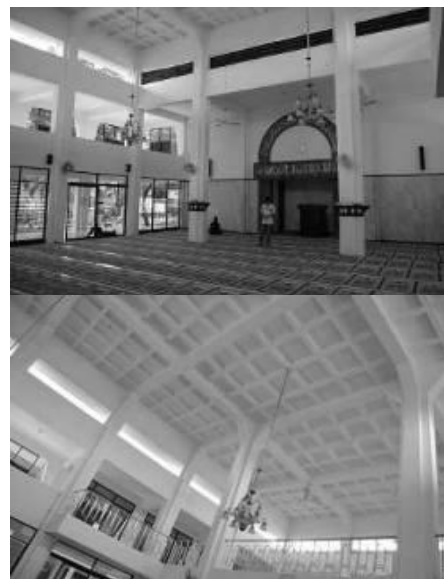
Figure 5. Interior of Masjid Baitussalam

Masjid Baitussalam (Figure 5) is located at Ketintang Madya Estate Surabaya. The location of this mosque is side by side with Baitussalam Junior High School and the main road that is the highest source of noise. The plan shape of this mosque is rectangle with the long side parallel to *kibla*. The ceiling shape is flat. The dimension of the mosque is 12,8 x 21,6 x 8 m³. The material of this mosque is a reflecting material, which are glass window, glass door, brick plester wall, and ceramic tile on the wall. All of the floor is covered by the carpet, so it could reduce the reflecting area. The opening area is 20% wall area. It also could reduce the reflecting area.
